## Existing Conditions

# SAFE ROUTES TO SCHOOL - Brookside Elementary Upper Campus

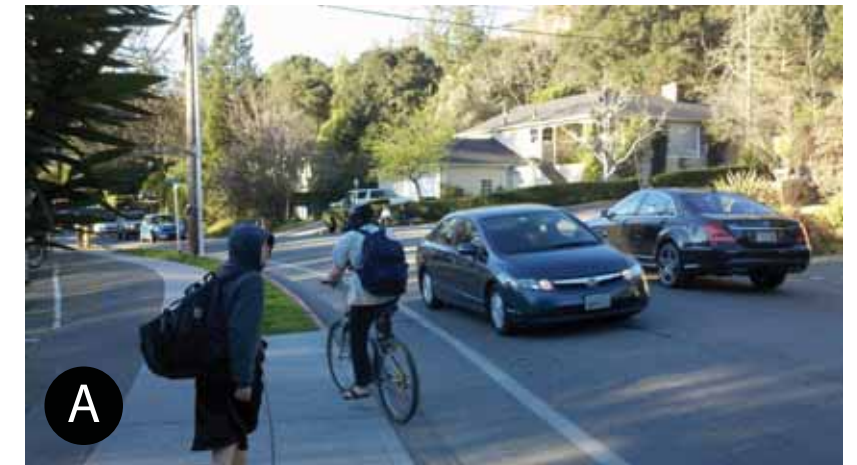
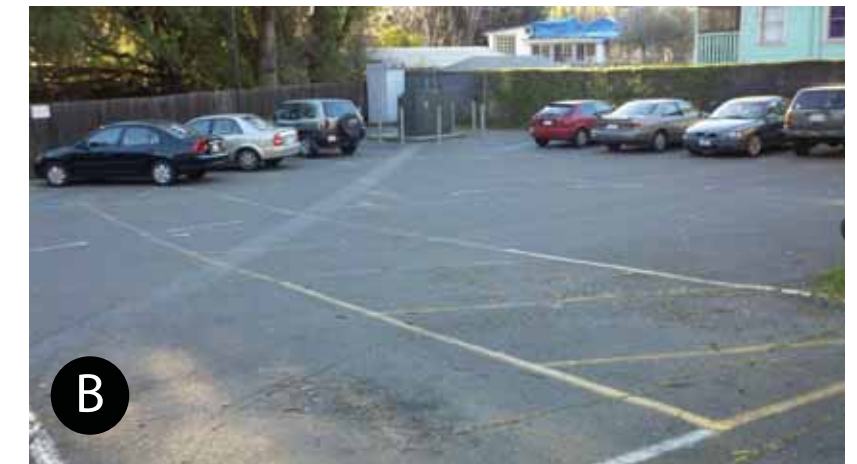
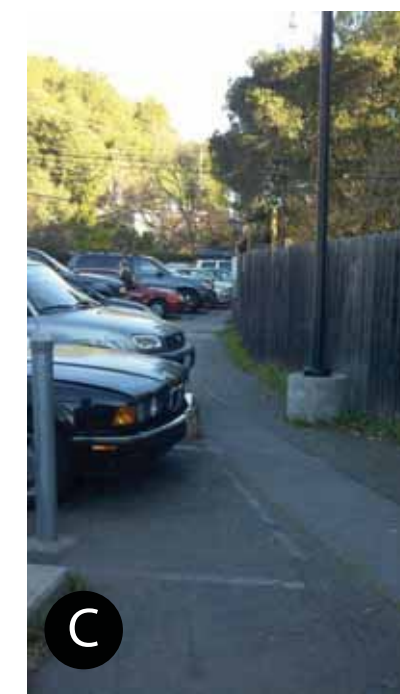
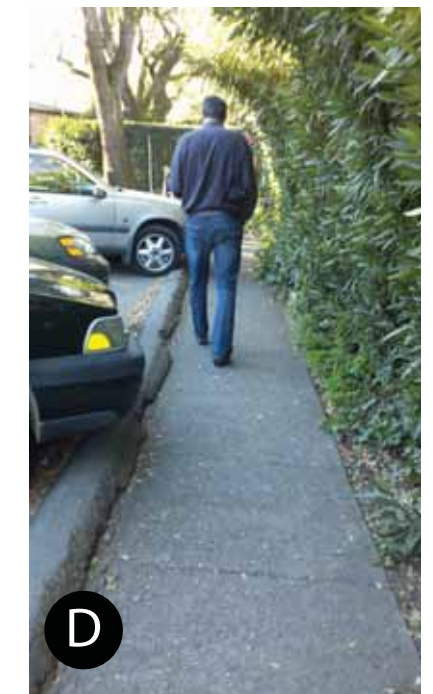
- Pedestrian access route to school from Butterfield Road is not clearly defined. Hatched yellow walking area is faded and rarely used.
- Parked vehicles encroach on sidewalk and parking lot perimeter paths, which are narrow, poorly defined, and at-grade with vehicles.
- Exit is located within functional area of "T" intersection on Butterfield Rd, acting as the fourth leg of an all-way stop. Current two-lane exit striping is incompatible with this condition and can be confusing to all modes when utilized.
- Children and parents tend to gather and spill out into the parking lot adjacent to the school entry and bridge crossing.

- A** Provide 6' continuous, protected walkway around parking lot perimeter to school entrance

- Remove existing asphalt curb, modify parking layout, and stripe or paint continuous walkway
- Relocate/replace concrete wheel stops or provide new physical barriers (e.g., bollards, planters, or barrier logs) to ensure vehicles do not overhang onto path

- Install 6' continuous sidewalk with 6" curb at edge of parking lot. Feather transition to match existing grades at existing sidewalk
- Relocate/replace wheel stops to ensure vehicles do not overhang onto sidewalk

- B** Provide curb or painted walkway extension into parking lot at school entrance to ensure adequate capacity and provide room for parental interaction/supervision

- C** Reduce parking lot exit to single lane and include appropriate buffer striping to maintain good visibility of sidewalk

- D** Repave or grind out existing parking lot striping. Eliminate striped walkway through lot and modify parking layout with primarily 60 degree angled parking for maximum efficiency and safety

- F** Consider continuous barrier (such as timber logs or salvaged utility poles) to prohibit vehicle encroachment onto exiting sidewalk
