## Existing Conditions

# SAFE ROUTES TO SCHOOL - Brookside Elementary Upper Campus

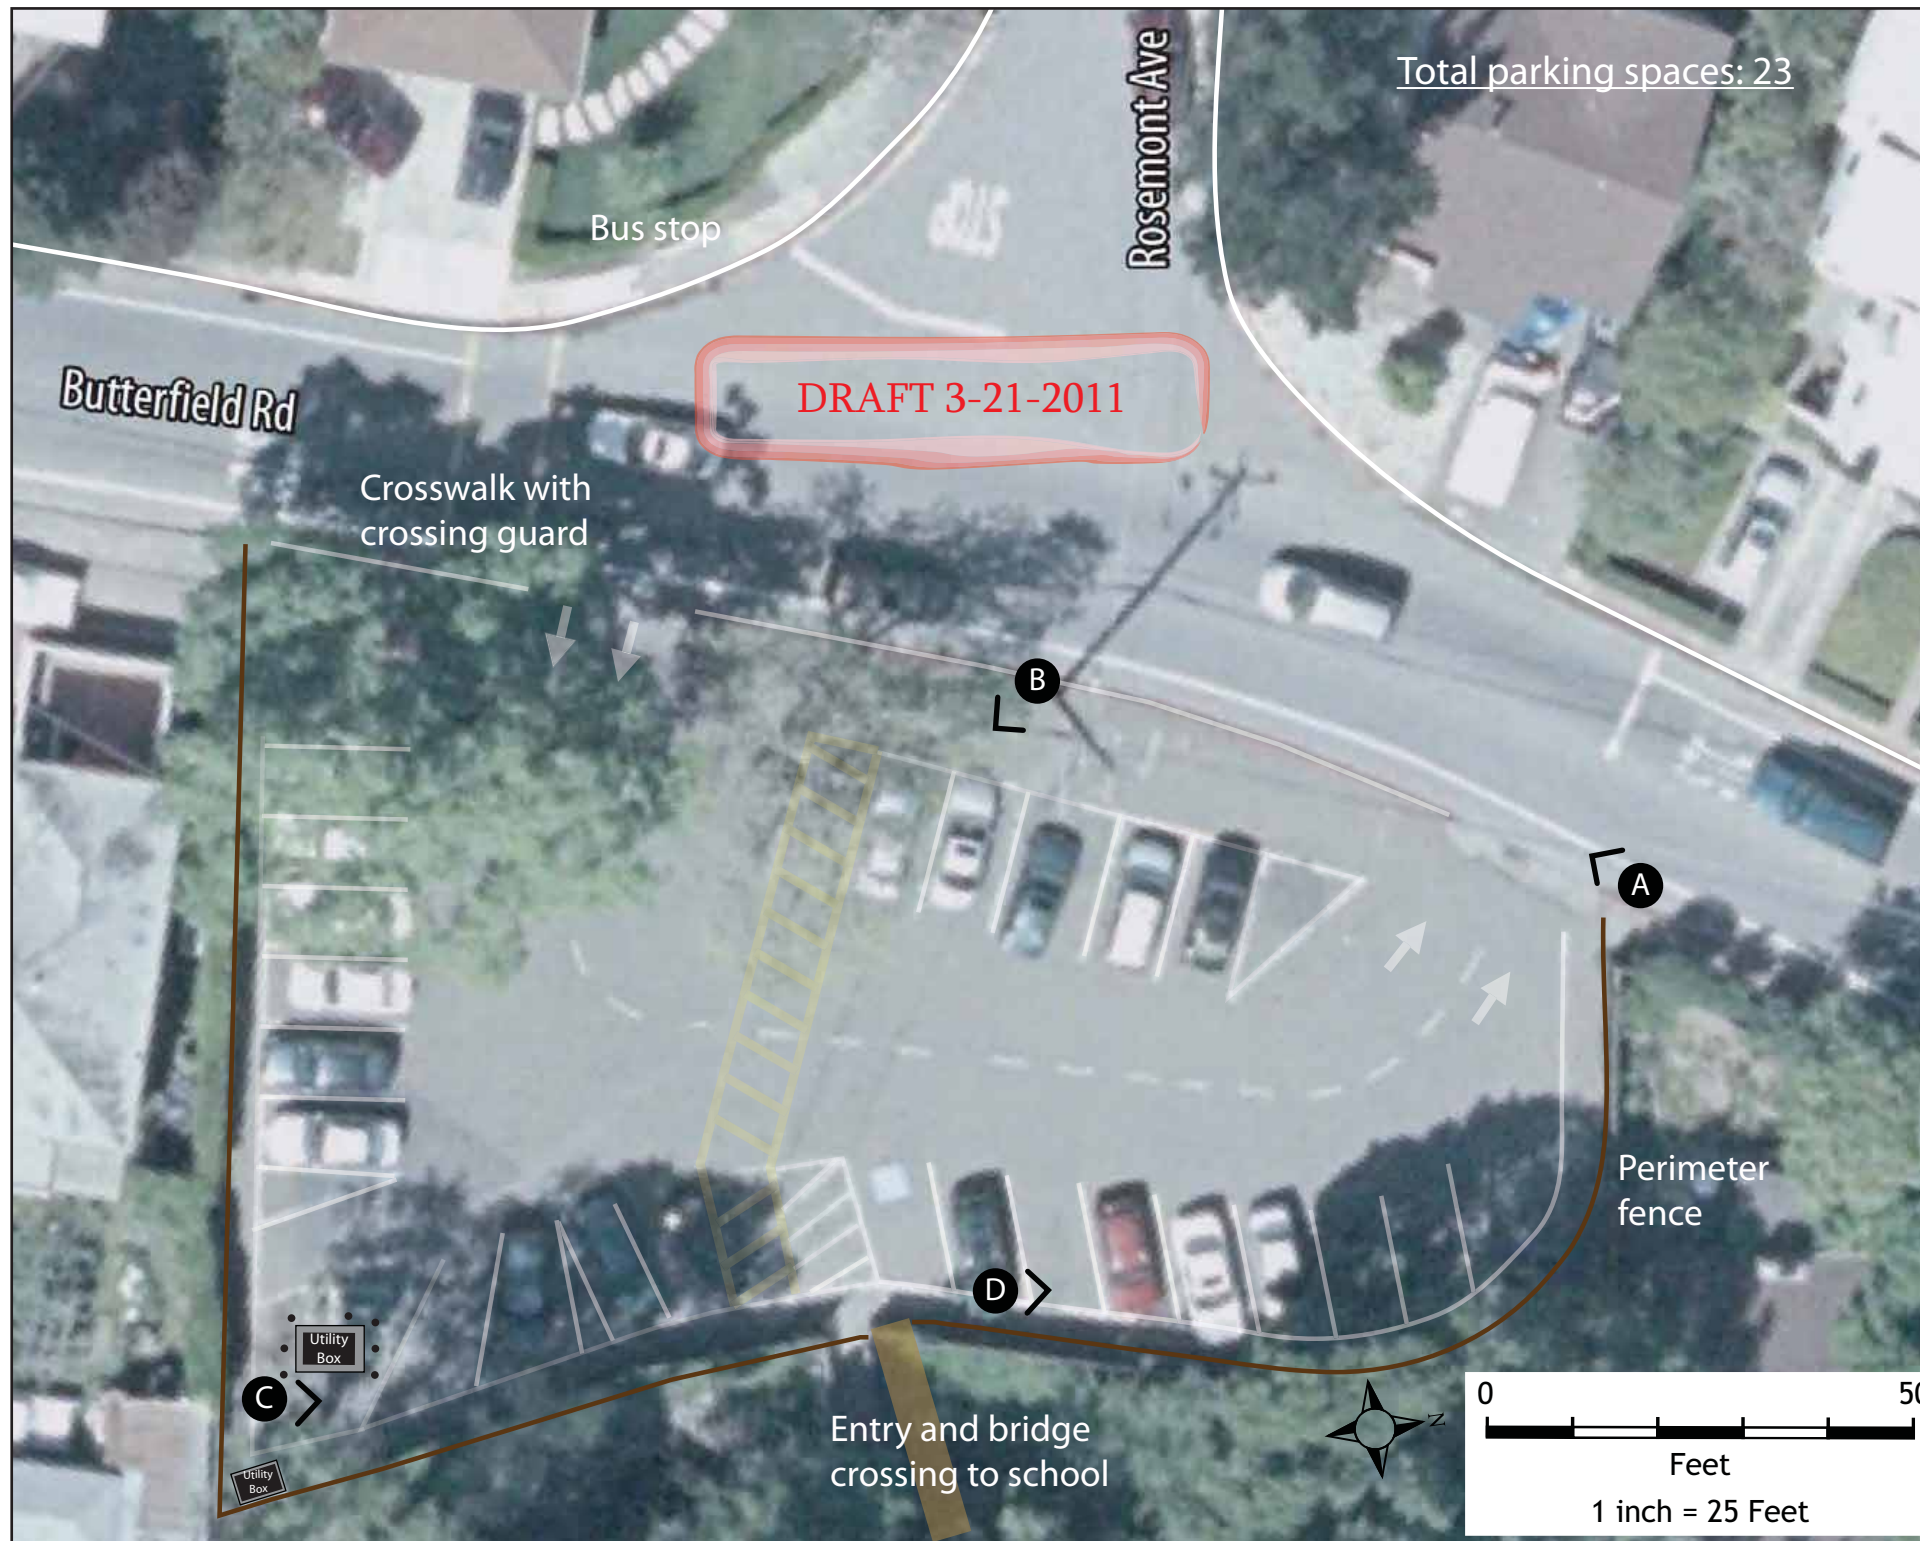
- Pedestrian access route to school from Butterfield Road is not clearly defined. Hatched yellow walking area is faded and rarely used.
- Parked vehicles encroach on sidewalk and parking lot perimeter paths, which are narrow, poorly defined, and at-grade with vehicles.
- Exit is located within functional area of "T" intersection on Butterfield Rd, acting as the fourth leg of an all-way stop. Current two-lane exit striping is incompatible with this condition and can be confusing to all modes when utilized.
- Children and parents tend to gather and spill out into the parking lot adjacent to the school entry and bridge crossing.
